Report No. CG-D-02-98

IMPROVED INSPECTION OF WOODEN VESSEL FASTENERS

U.S. Coast Guard
Research and Development Center
1082 Shennecossett Road
Groton, CT 06340-6096

Final Report
August 1997

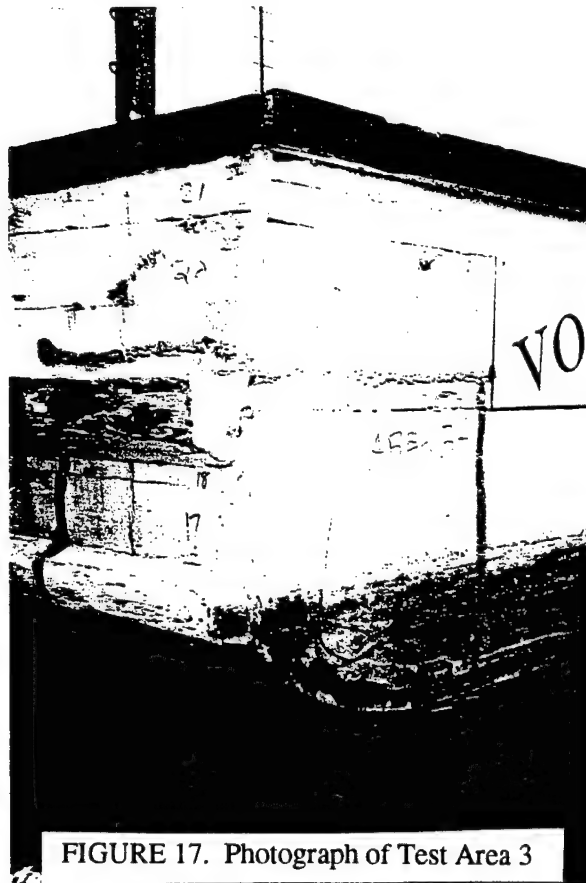
FIGURE 17. Photograph of Test Area 3

The stern area was unique because it was very accessible from the inside and outside. A view of the outside is shown in Figure 17 and the inside in Figure 38. There is no ceiling material that covers the frames at this location and the fuel tank did not extend to the corner. Note the nut in the oak timber to the left of the letter "A." This bolt is seen in both the conventional and real time

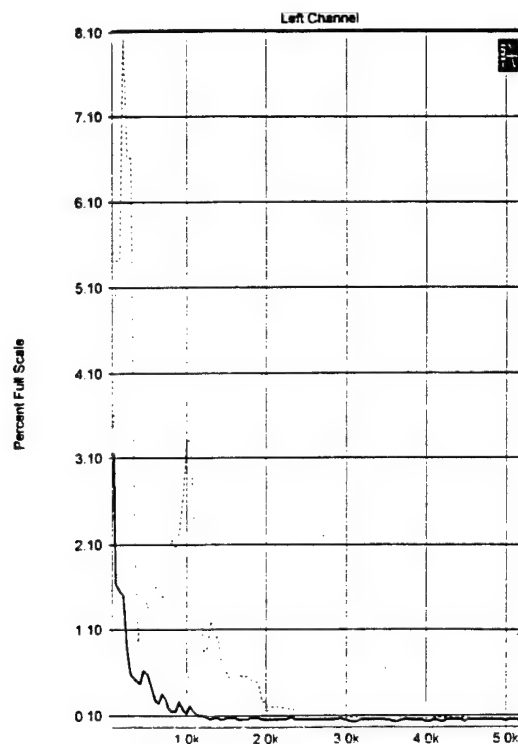
FIGURE 23. SMART HAMMER Results of good vs rotten areas
(dotted line = good plank, solid line = rotten area)

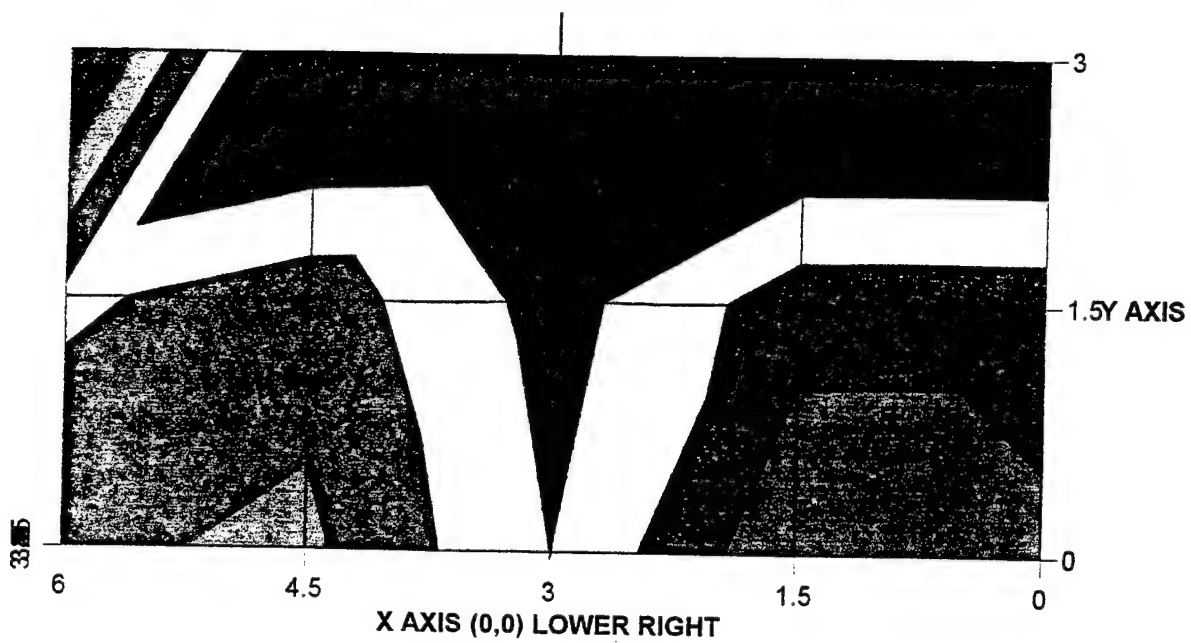
FIGURE 30. Capaciflector Results Questionable Joint

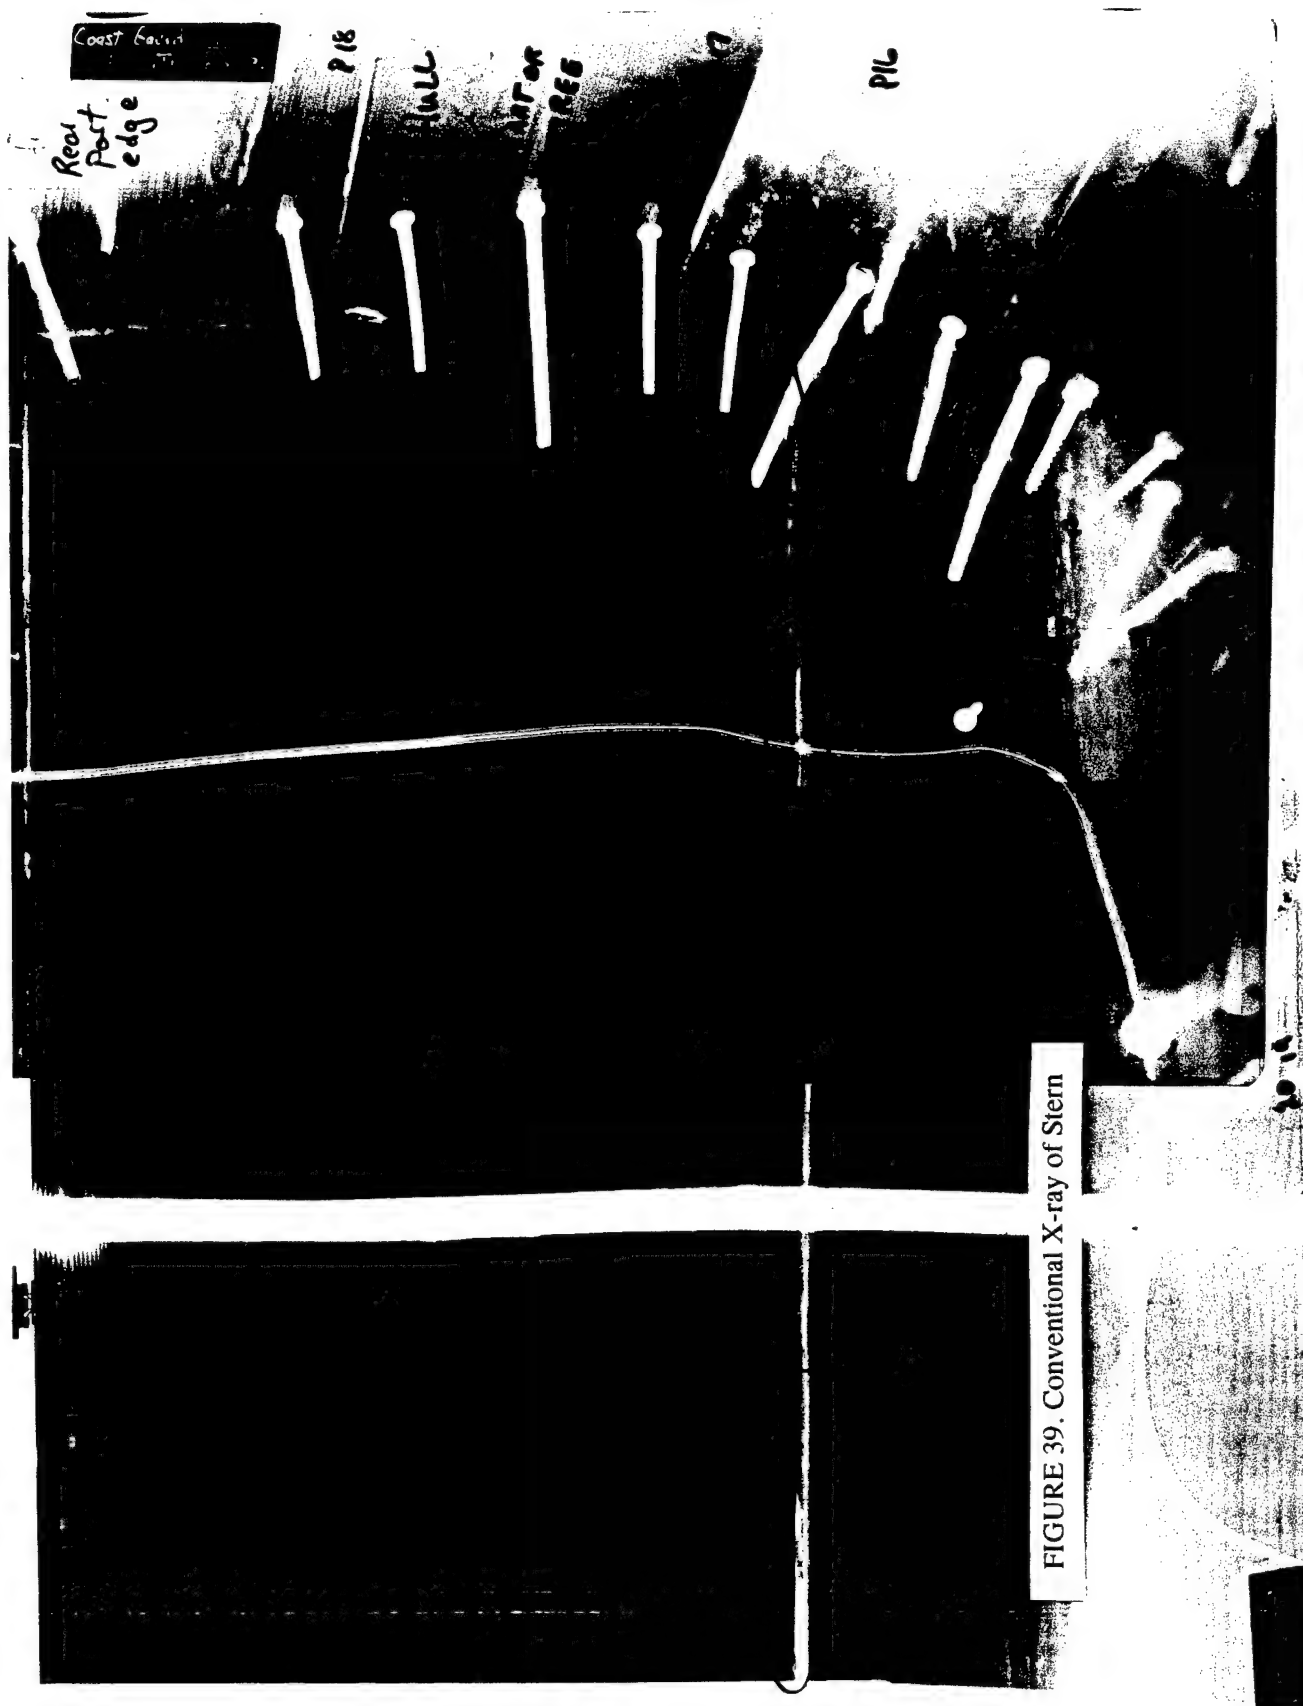
FIGURE 39. Conventional X-ray of Stern

the oak timber to the left of the letter "A." This bolt is seen in both the conventional and real time x-rays (see fastener # 18 on the conventional x-ray in Figure 39). The outline of the oak timber can also be seen in the x-rays. The conventional x-ray was taken with two overlapping pieces of film attached to the outside of the hull and the source inside on the deck. (Figure 39) This shot was taken with the source approximately 36 inches away from the film. A 2½-minute exposure was used using 120 KV with 2½ milliamps. Examples of good fasteners are numbers 3, 4 and 5. These can be seen in the photograph in Figure 40. Note in the x-ray, the outlines of these fasteners are very distinct. The lighter color near the head is the wooden bung placed over the fasteners. Closer to the waterline, the fasteners in the x-ray begin to have less distinct shapes and almost seem to have a halo-type ring around them. In this case, the oxide created by the corrosion process has a different density. The effect can be seen in fasteners 7 and 9 in Figure 41 and fasteners 10 and 13 in Figure 42. On the other hand, for the stainless steel screws (11 and 12), the threads can be seen and found to be in excellent condition (Figure 42).

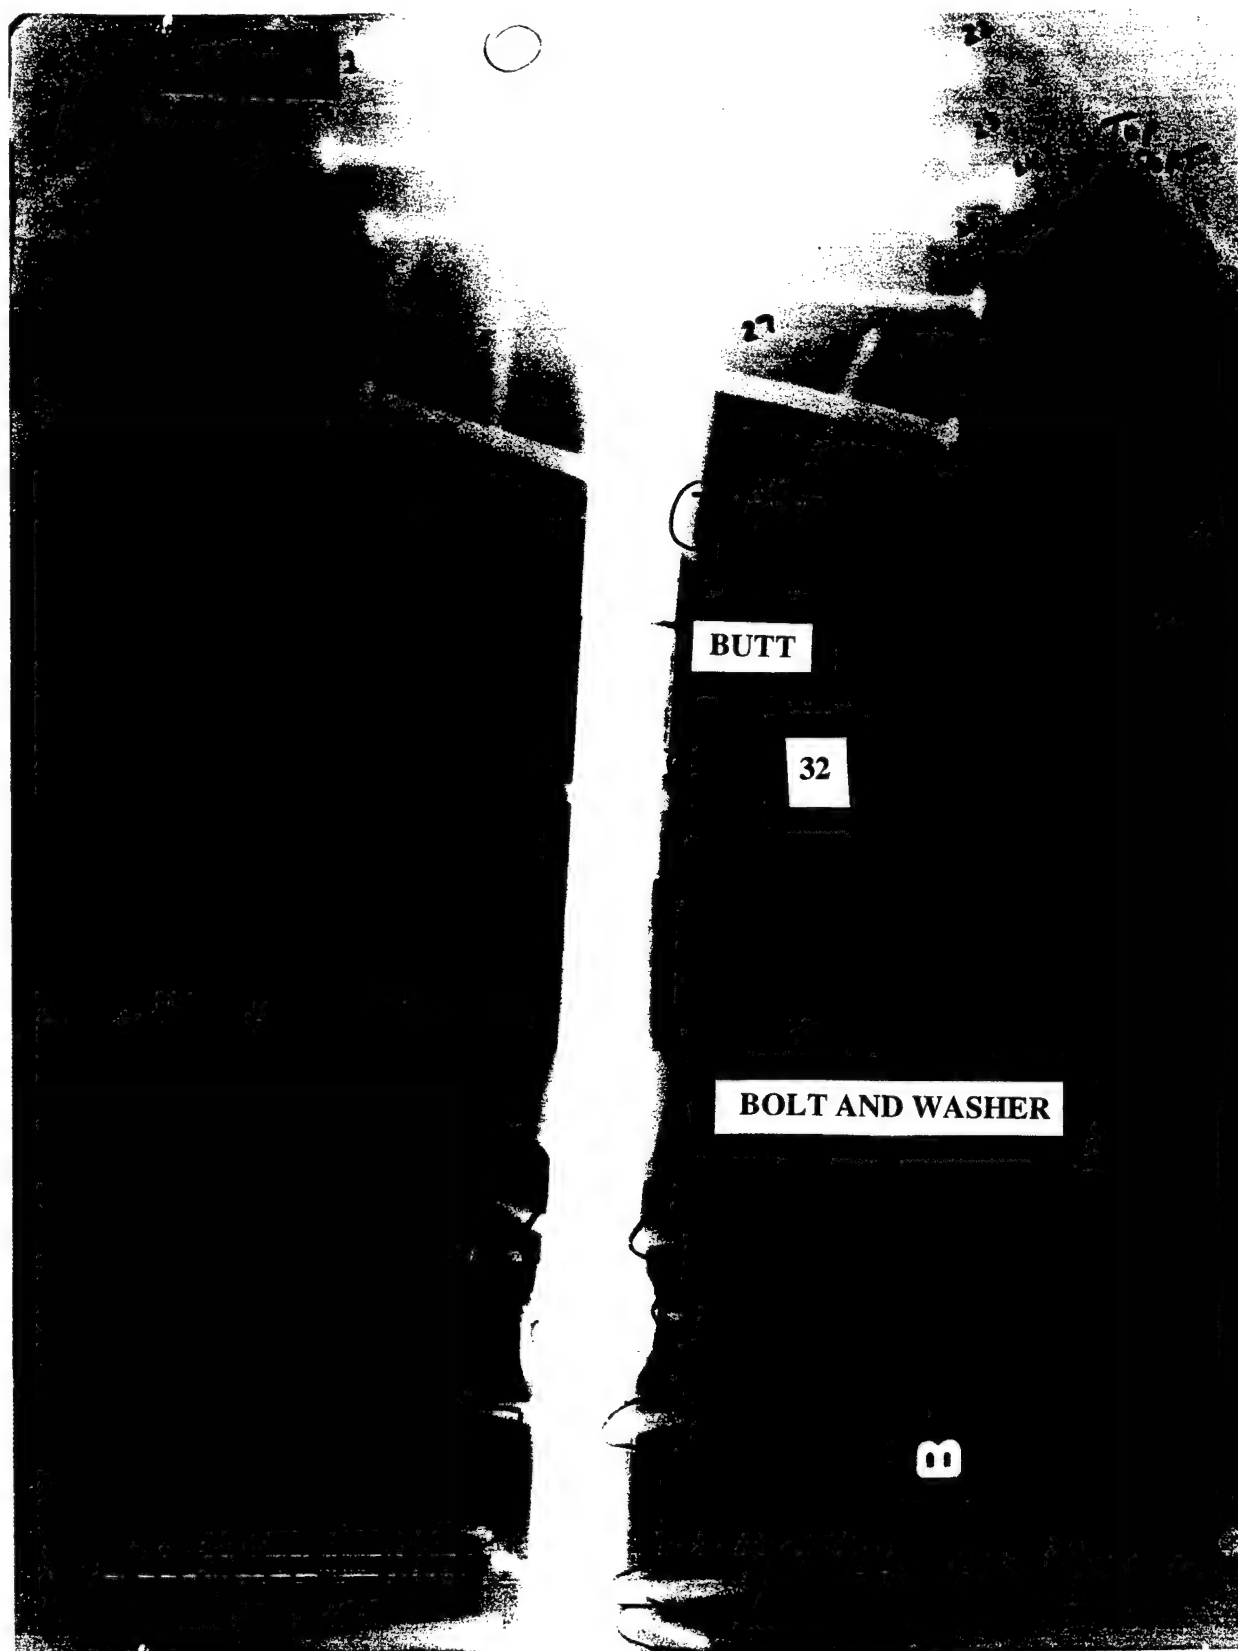
FIGURE 47. Conventional X-ray of Stem

Just below the center of the x-ray in Figure 47, the washer (near the center of the figure) and the head of a bolt (nearer the bottom) can be seen. This was a major attachment of the stem to the knee and is in generally good condition although the x-ray does not provide any information. Near the bolt there are several partially corroded fasteners just to the right of the stem band. The center of the fastener which still has good metal is surrounded by a slightly lighter layer of oxide. The difference can be seen in the actual amount remaining in the fasteners in Figure 51. The upper fasteners (15,22,23,32) are all in good condition while the ones located below the waterline show extensive wastage as predicted by the x-ray. It is important to note that all

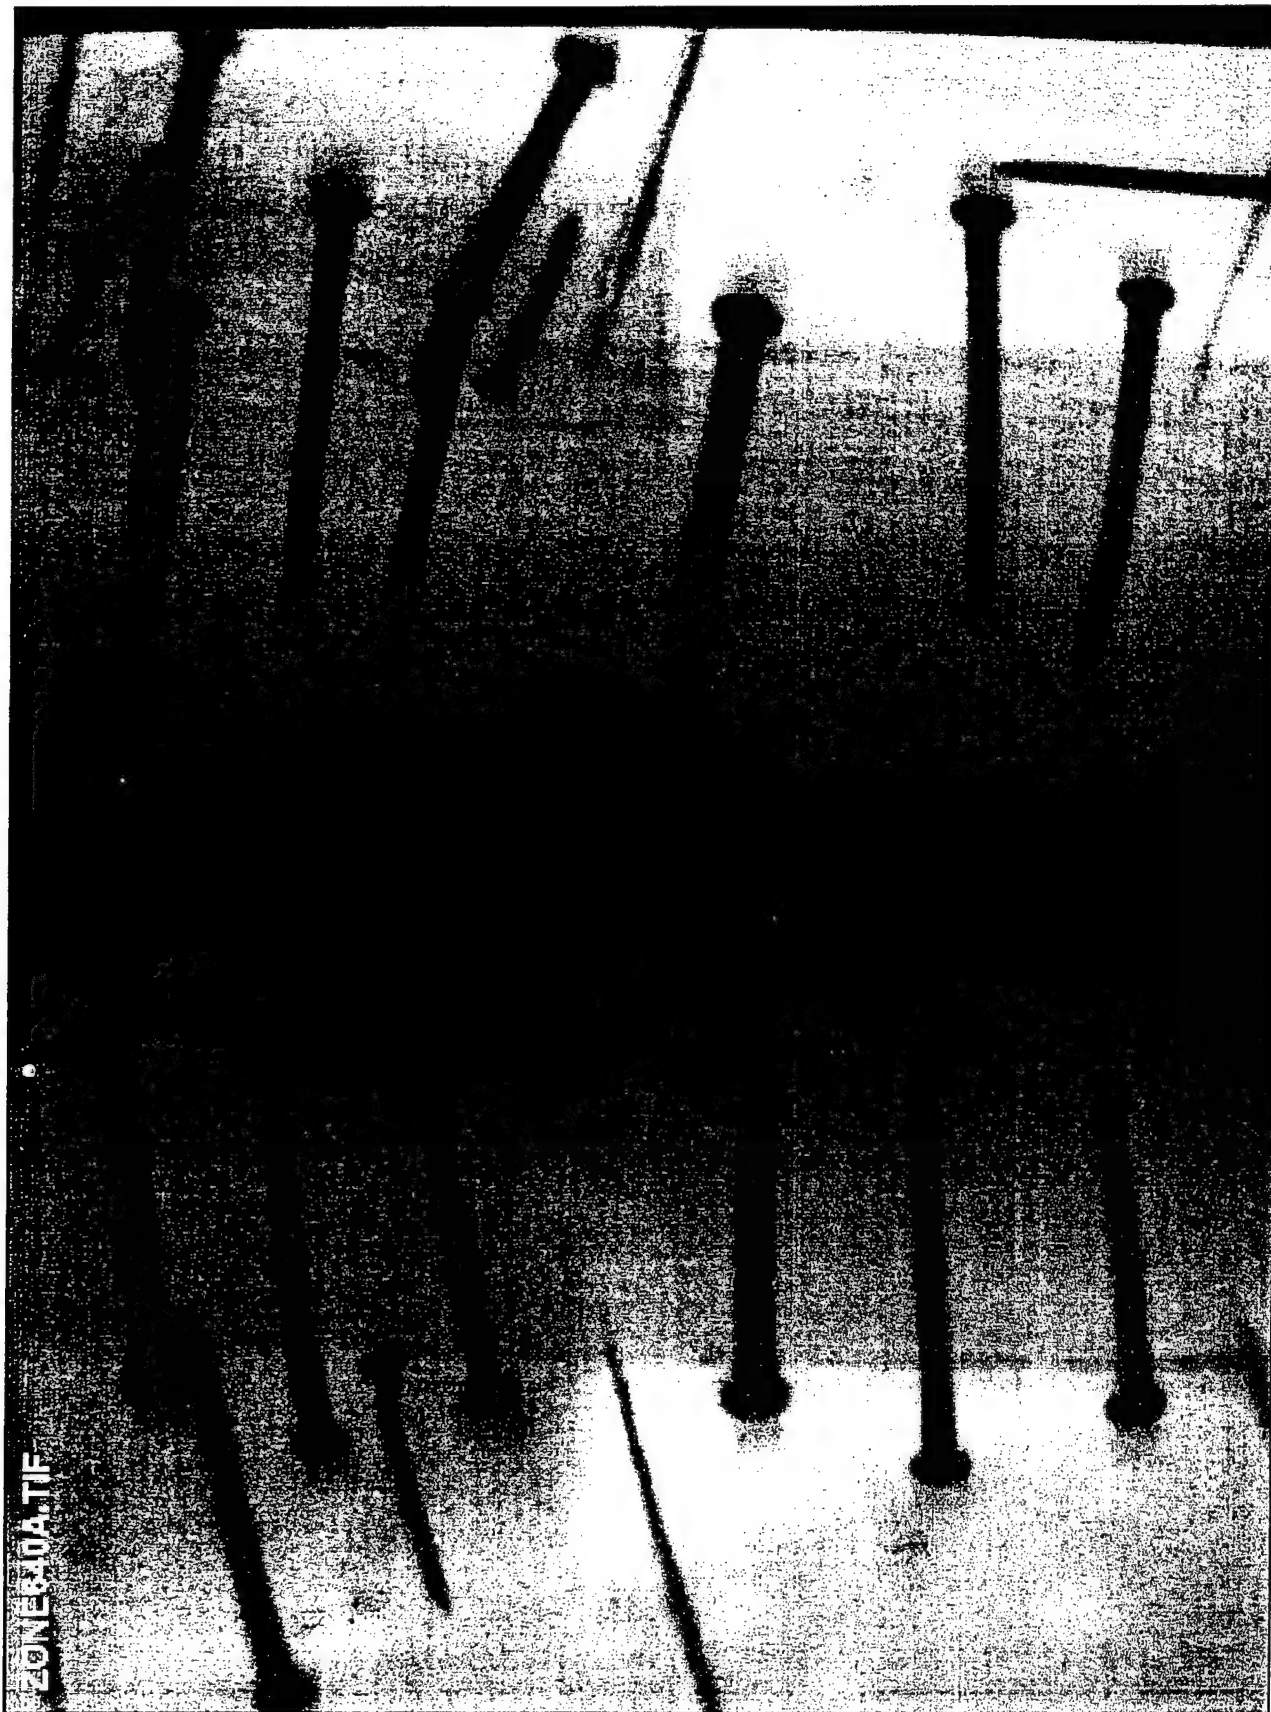
FIGURE 52. Real Time shot of stem at 40 inches from deck

The real time x-rays were also taken with the source inside of the vessel. The three shots shown in Figures 52-54 start about 40 inches down from the deck level and step down about 8 inches each time. The butt joint in the stem band can be seen just above the center in Figure 54. There are two issues involved in viewing the figures here. First, the source was moved to different locations between some of the shots so that the relative position of the fasteners changes. Second, the lower energy real time system had some difficulty penetrating the large amount of structure as can be seen in Figure 54. These two issues, plus the lack of reference points, such as the bronze bolt, make it difficult to interpret the results.

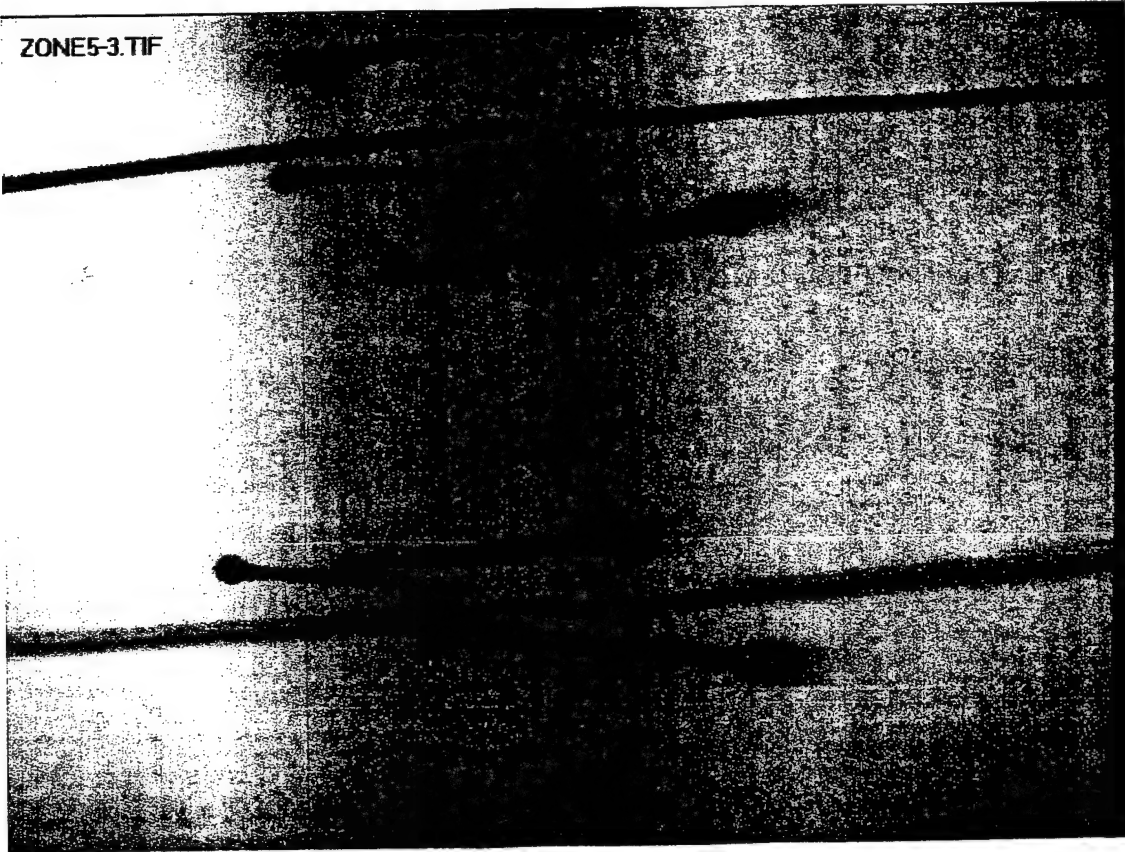
FIGURE 55. Real Time shot of Area 5

There were x-rays taken of other parts of the vessel, but conventional and real time shots were not taken in the same place. Real time shots were taken of Area 5 because the equipment was portable enough to be moved to that area. (Figure 55) The plank and the ceiling fasteners can both be seen. As expected, the fasteners in this area are in good shape and this was confirmed when taken apart (See Figure 56) Holes can be seen where the fasteners were removed.

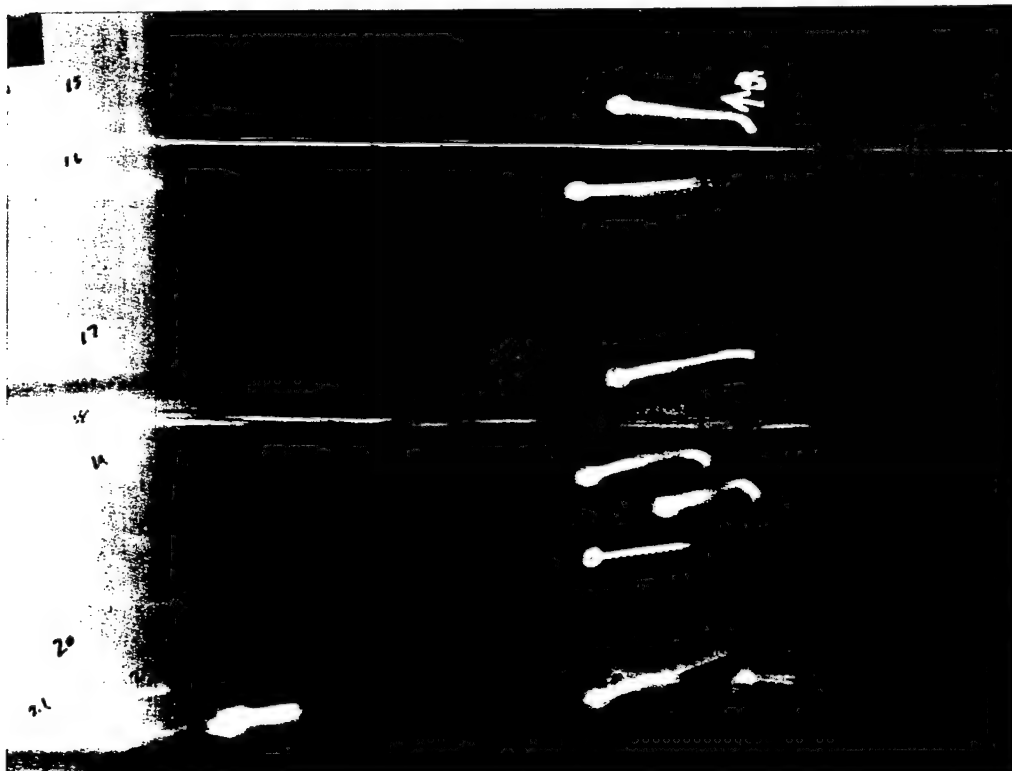
FIGURE 73. Conventional X-ray of Plank (45 degrees, ASA80)

For the shots taken at a 45 degree angle, two different films with different speeds were used. The normal medium speed (ASA 80) is used in Figure 73. For these shots, the film was placed back to back and only one exposure time was necessary. As a result, the faster film (ASA 100) shown in Figure 74 appears darker. In actual use, the exposure time could be reduced for this faster film or a thicker piece of wood could be examined. Both show the condition of the fasteners in sufficient detail, although the light film picked up other details. The real time shot (Figure 75) also detects the fasteners. In addition, the 45 degree shots show that fasteners are in two pieces which is not as obvious in the real time 30 degree shots, especially for the fastener just above and to the right of the sheetrock screw. Also note that the fasteners near the bottom of all of the figures have lost the clinched ends. These detached when the hull was disassembled and they contained insufficient strength. A real time shot was taken at a 60-degree angle (see Figure 76). Although the condition of the fasteners can be determined, the distortion is very severe and this amount of angle should only be used for special cases.

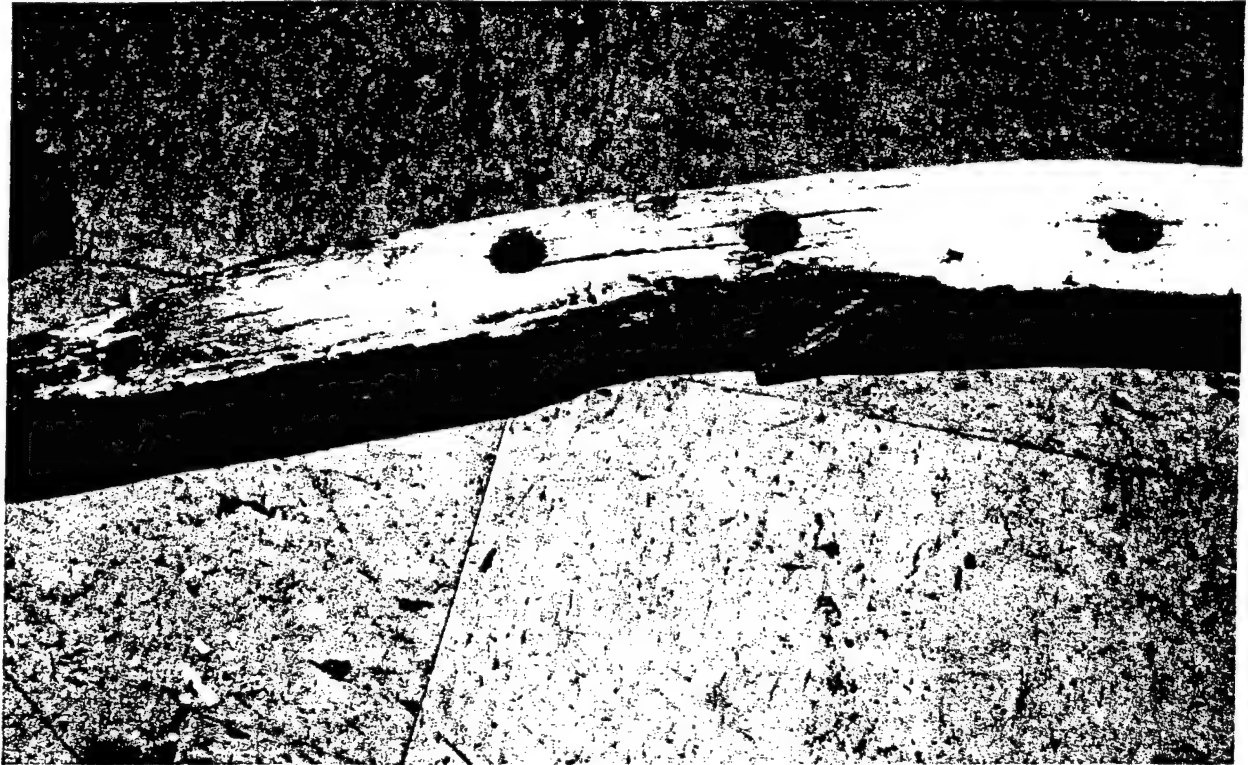
FIGURE 77. Photograph of Frame Side

Finally, two shots were taken of a bent frame from another vessel to show the difficulty in interpreting results due to coatings. Figure 77 shows a view of the frame and a corresponding x-ray in Figure 78 (shown on top of a 2x4). Even more dramatic are the coatings shown in Figure 79 which result in an x-ray with varying density (see Figure 80). The changes in the darkness of

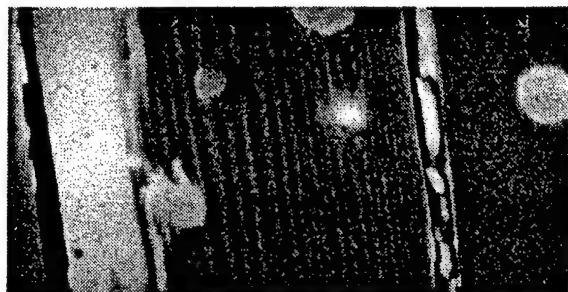
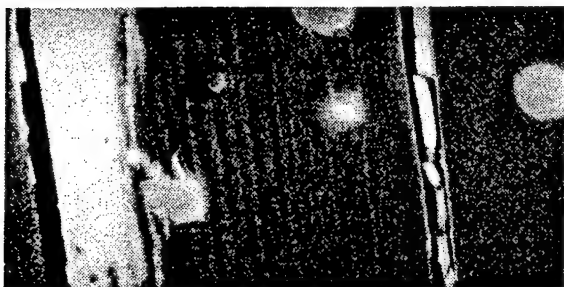
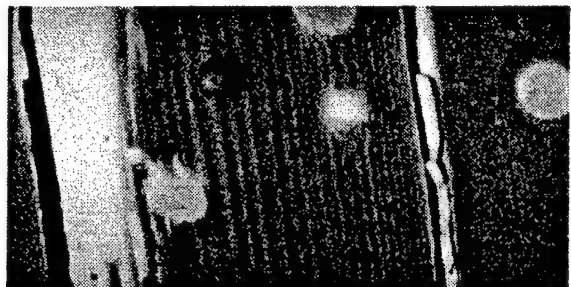
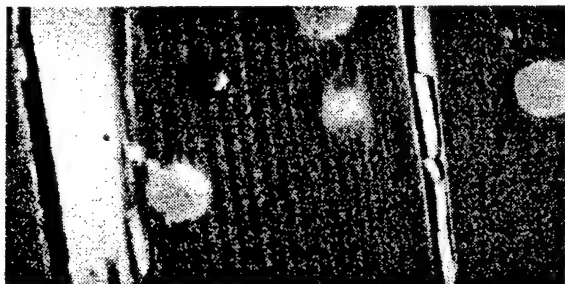
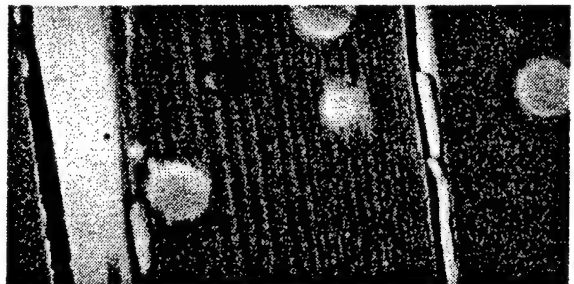
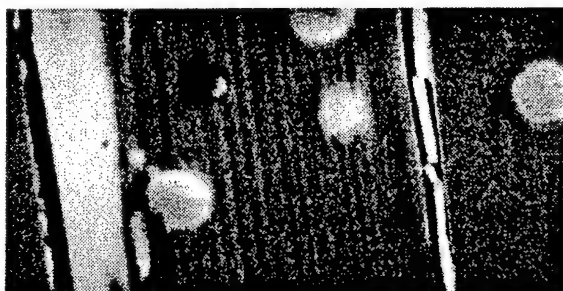
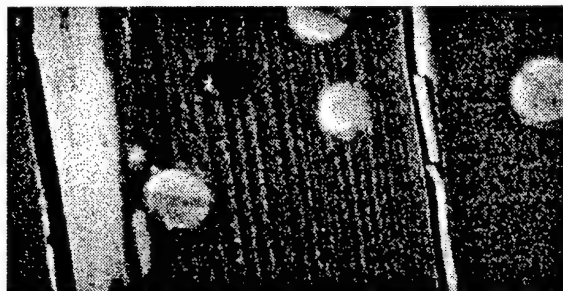
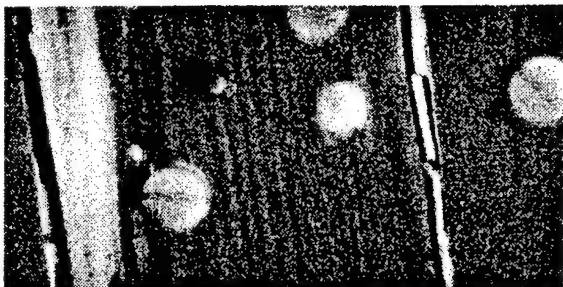
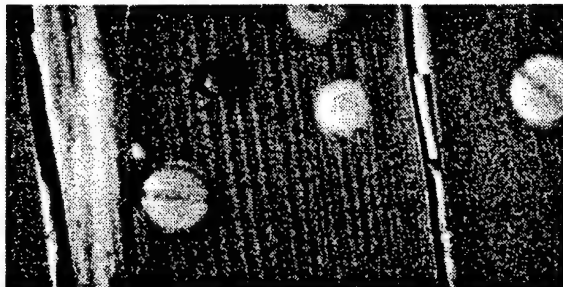
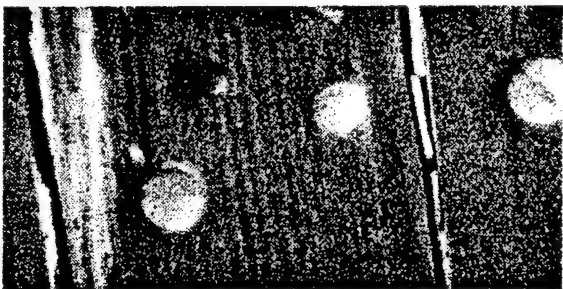
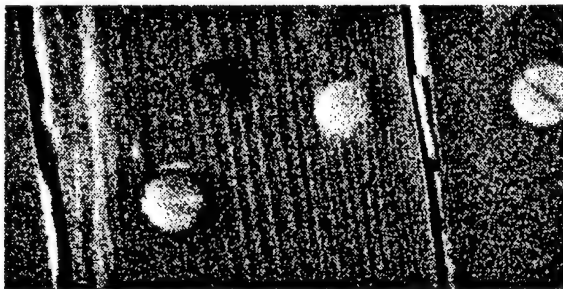
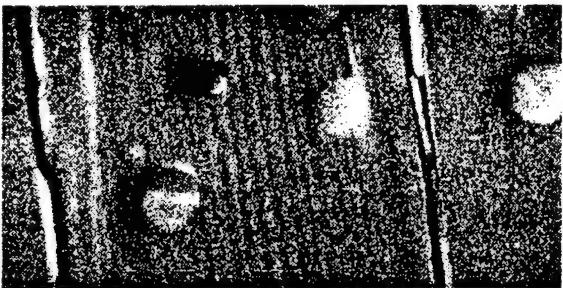
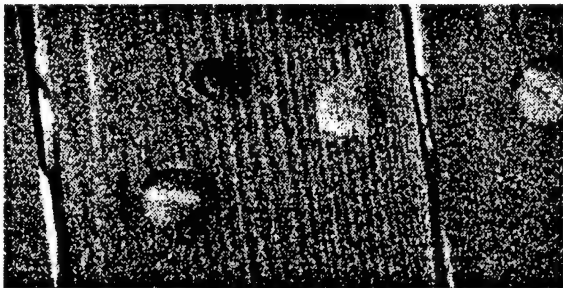
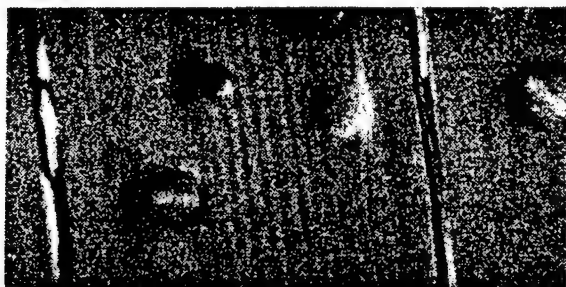
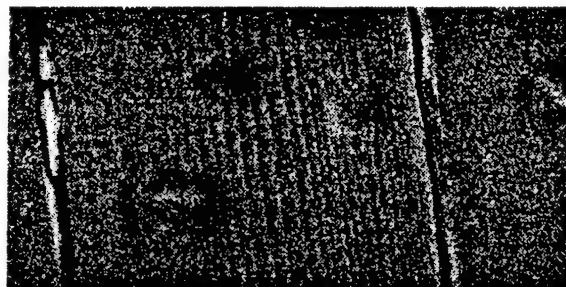
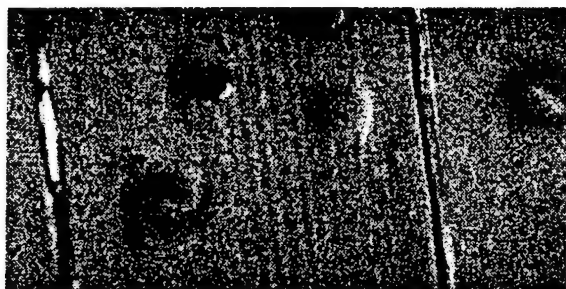
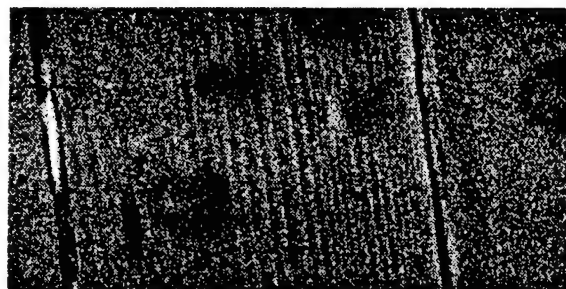
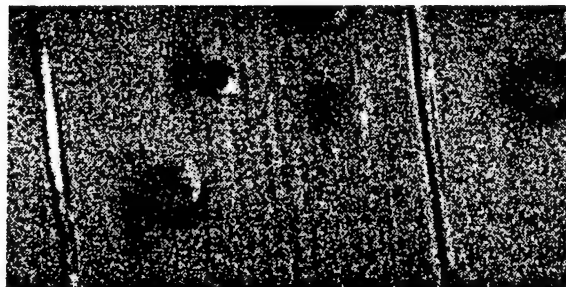
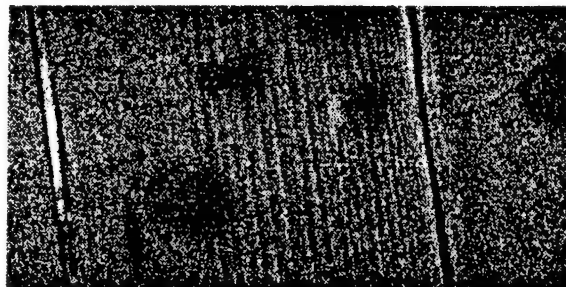
FIGURE 81. Backscatter X-ray Results

An x-ray backscatter method was attempted using a system developed by the Naval Research Laboratory. A set of images is seen in Figure 81. Each image represents a 50 mm by 100 mm (about 2 inches by 5 inches) slice about 0.5 mm thick. It is easy to identify caulk, screw hole filler, fasteners and changes in wood density. The hole filler material is seen up to about level 11 or 12 where the heads of the screws appear. The shadow of the heads continues on the images as deeper shots are taken.

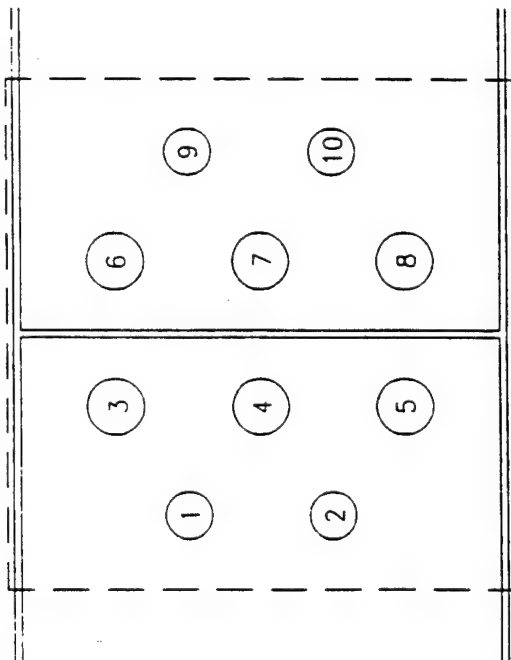
BUTT 1 (TOP)

FASTENING POSITION	FASTENING TYPE	DEFECT TYPE
T1	SCREW	S2
T2	SCREW	-
T3	BOLT	-
T4	BOLT	B1
T5	BOLT	B2
T6	BOLT	B2
T7	BOLT	-
T8	BOLT	B1
T9	SCREW	S1
T10	SCREW	-

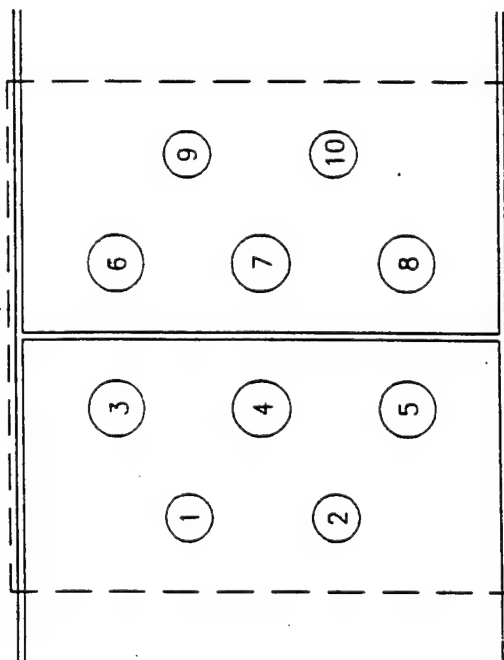
BUTT 2 (BOTTOM)

FASTENING POSITION	FASTENING TYPE	DEFECT TYPE
B1	SCREW	-
B2	SCREW	S1
B3	BOLT	-
B4	BOLT	B2
B5	BOLT	-
B6	BOLT	B1
B7	BOLT	-
B8	BOLT	B2
B9	SCREW	S2
B10	SCREW	-

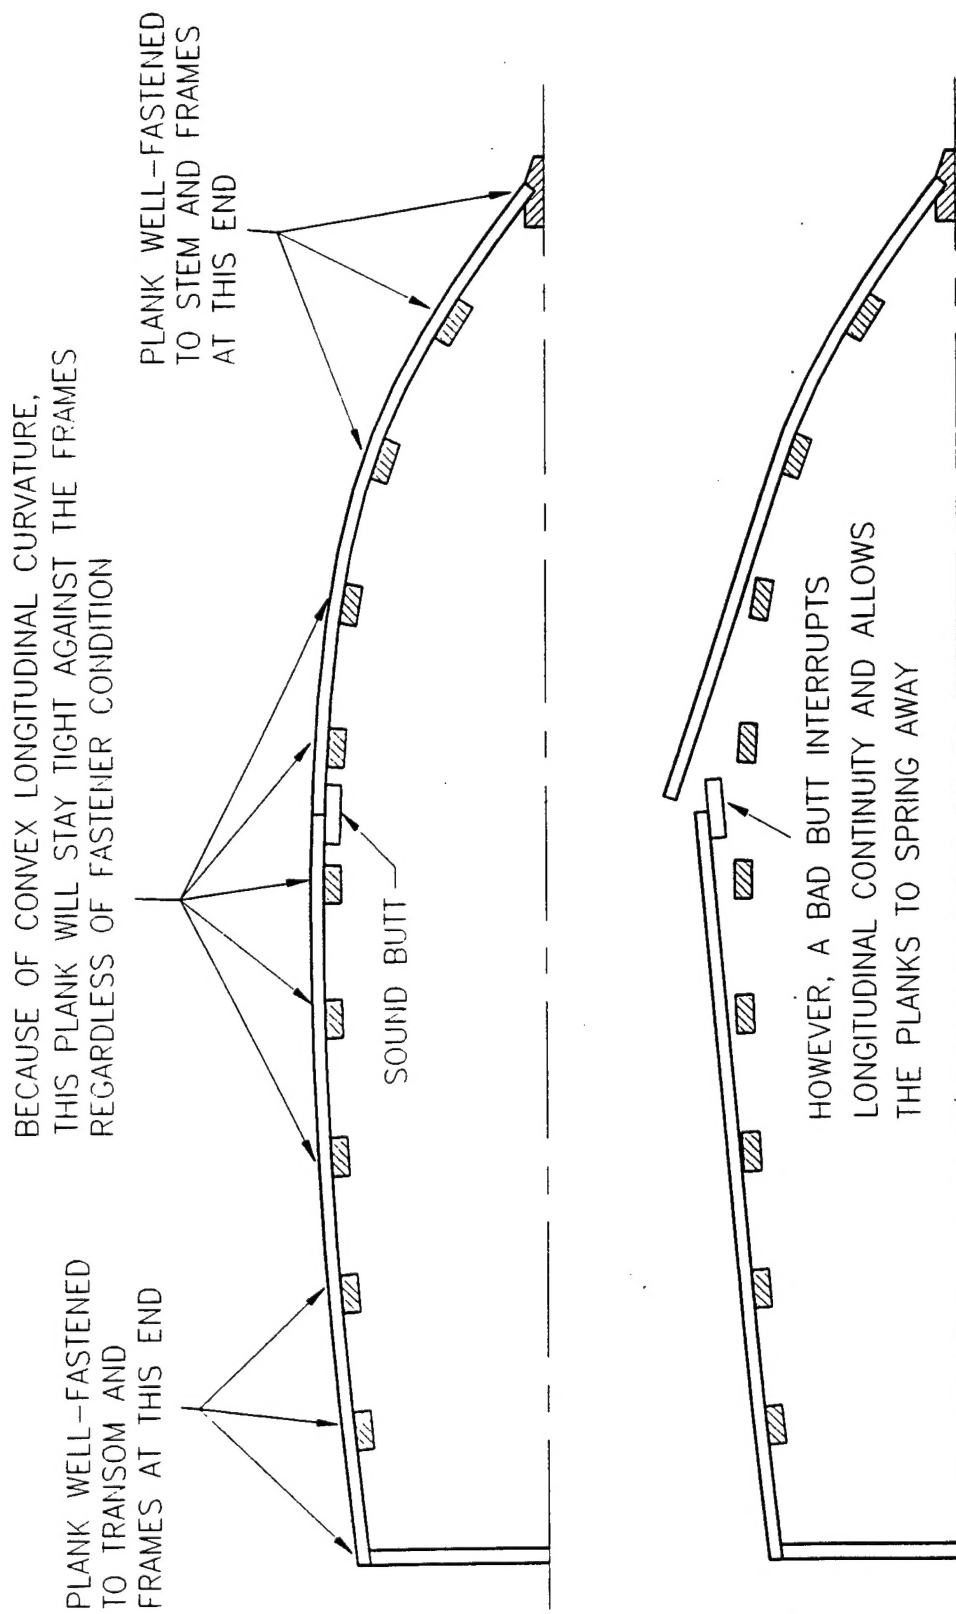
FIG. 1

Despite the condition of the fastenings in these planks, the planks were not showing any signs of falling off the boat. These planks were no longer fastened mechanically, but were held onto the boat geometrically for two reasons. First, since the planks were still apparently well-fastened toward the ends of the boat, and since the hull surface is longitudinally convex, the planks stayed against the frames amidships despite the condition of the fastenings. This situation is illustrated in Figure 1. Second, the transverse sections of the hull in this area are concave outside, so the swelling and caulking stresses between the planks push them tightly inward against the frames, the keel, and the floor timbers. This situation is illustrated in Figure 2. Higher up where the hull surface is convex, planks with fastenings in such a deteriorated condition would be pushed off the boat, away from the frames, by the same transverse compressive stresses that keep the lower planks on the boat. Inspecting by the hammer method may be deceiving in areas of concave transverse curvature, since the tightness of the planking to the frames, which is what the surveyor or inspector is feeling for, is not dependent upon the condition of the fastenings, as it is in most other areas of the hull.

In the case of these butts, the first type of geometric restraint (shown in Fig. 1) does not apply, since there is no fore-and aft structural continuity remaining in the individual planks with the butt fastenings gone. The garboard butts were held in place solely by the reverse curvature of the section (as shown in Fig. 2). This situation was further worsened by the completely deteriorated condition of the nails into the keel rabbett along lower edge of the garboard plank forward and aft of the butt. Despite the condition of these butts, none of us, using traditional survey techniques, had found any cause for great alarm.
